#17-H-030: LS3 L77 (V8) Engines Mil Light, Powertrain DTCs, COMS DTCs or Blown fuses - (Aug 24, 2017)

Subject: 17-H-030 — L77 / LS3 (V8) Engines Mil light, Powertrain DTC's, COMS DTCs or Blown Fuses

Brand:	Model:	Model Year:		VIN:		Engine:	Transmission:
		from	to	from	to		
Holden	VF / WN	2014	2016	VF SOP	6G3F15RW9HL301827	L77 / LS3 (V8)	MER (Manual) / MYC (Auto)

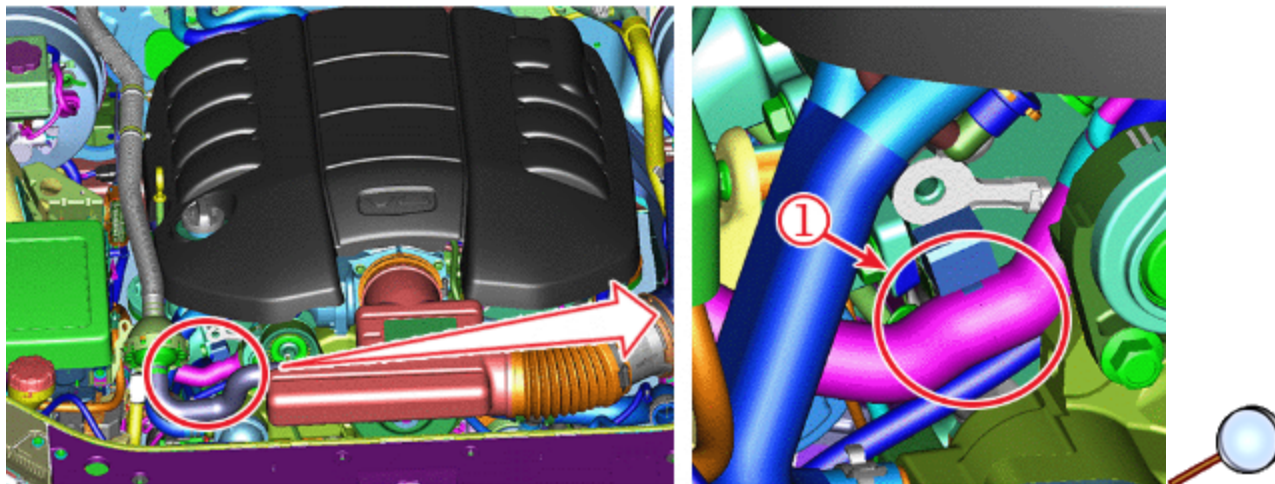
1. If presented with an affected vehicle with the above condition, inspect the engine wiring harness near the right hand side manifold for damage (1).
2. Once confirmed, repair any damaged wires following eSI procedures.
