#21-H-004: Technical Service Bulletin – Vibration – Boom 90–100 km/h - (Apr 19, 2021)

Note: This bulletin replaces Techline TL2512-1409.

Brand:	Model:	Model Year:		VIN:		Engine:	Transmission:
		from	to	from	to		
Holden	VF Commodore	2014	2017	-	-	All	All
	WN Caprice

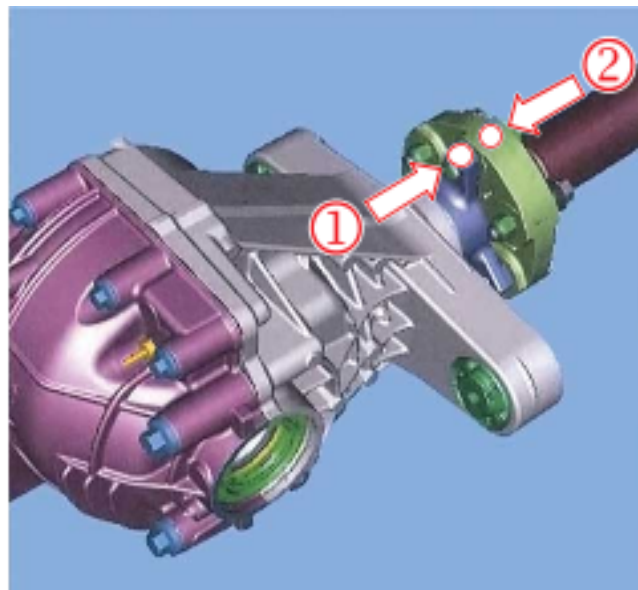
The propeller shaft and differential pinion flange are marked with orientation marks (1,2) so that when they are assembled at the vehicle assembly plant any minor imbalances cancel each other out so as to achieve optimum balance. This is known as 'phase matching', Refer to illustration above.

In some instances however, the point of highest imbalance may fall in between two of the flange mounting bolt holes, in which case the closest mounting hole is marked/used. This condition can occur to both the propeller shaft and the differential flange.

As a result, although the balance markings are aligned during assembly, it may be possible that any imbalance points of the prop-shaft and differential flange may not be in their optimum positions.

Correction — Production	There is continuous improvement activities underway in both the component supplier and assembly plant to reduce any imbalance issues.
Correction — Service	After road-testing confirms a vibration or boom is only present between 90-110 km/h and unrelated to engine load & RPM, and tyres/wheels have been eliminated as a cause, then trial the propeller shaft mounting in alternate positions via the procedure detailed in this bulletin.
