040

Make: Holden

Model: VS Commodore V6

Subject: Oxygen Sensors

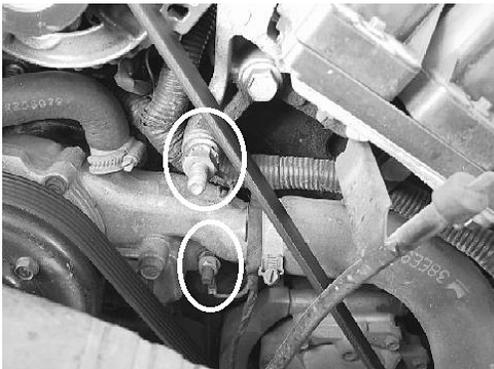
At Injectronics we often receive calls regarding VS Commodores, from mechanics complaining of one bank of injectors (V6) running richer than the other. Apart from occasional ECM faults, the most common fault is with the oxygen sensor earth points. The VS V6 is fitted with two zirconia tipped oxygen sensors located in the front engine pipes which should begin to operate in closed loop once exhaust temperature has reached approximately 320°C. Each sensor has it's own individual earth point, one being on the DFI module mounting stud and the other being on the engine front cover as seen in diagrams below. These earth points correspond to PCM terminals D14 and D16 (sensor reference grounds) and when tested should always be below 0.1 volts.

It is imperative that these earth points are clean and below 0.1 volts as the ECM compares the O2 sensor voltage signal to the earth point and if this earth point or reference is not at zero volts the ECM will not trim the fuel mixture correctly. If these earth points (PCM terminal D14 or D16) are at a different voltage levels, it will result in a different fuel trim for each bank.

V6 DIS Module mounting stud
(top circle)

V6 Engine front cover
(bottom circle)
