Thread: [Air-conditioning Compressor Pulley Bearing Replacement](#)

As the title suggests this how-to is on replacing the aircon compressor pulley bearing, this how-to will be based on a V6 VP Berlina, but the procedure should be the same for most cars, the VP uses a Sanden compressor. I completed this job with the compressor still on the car, and I didn't have to de-gas the aircon.

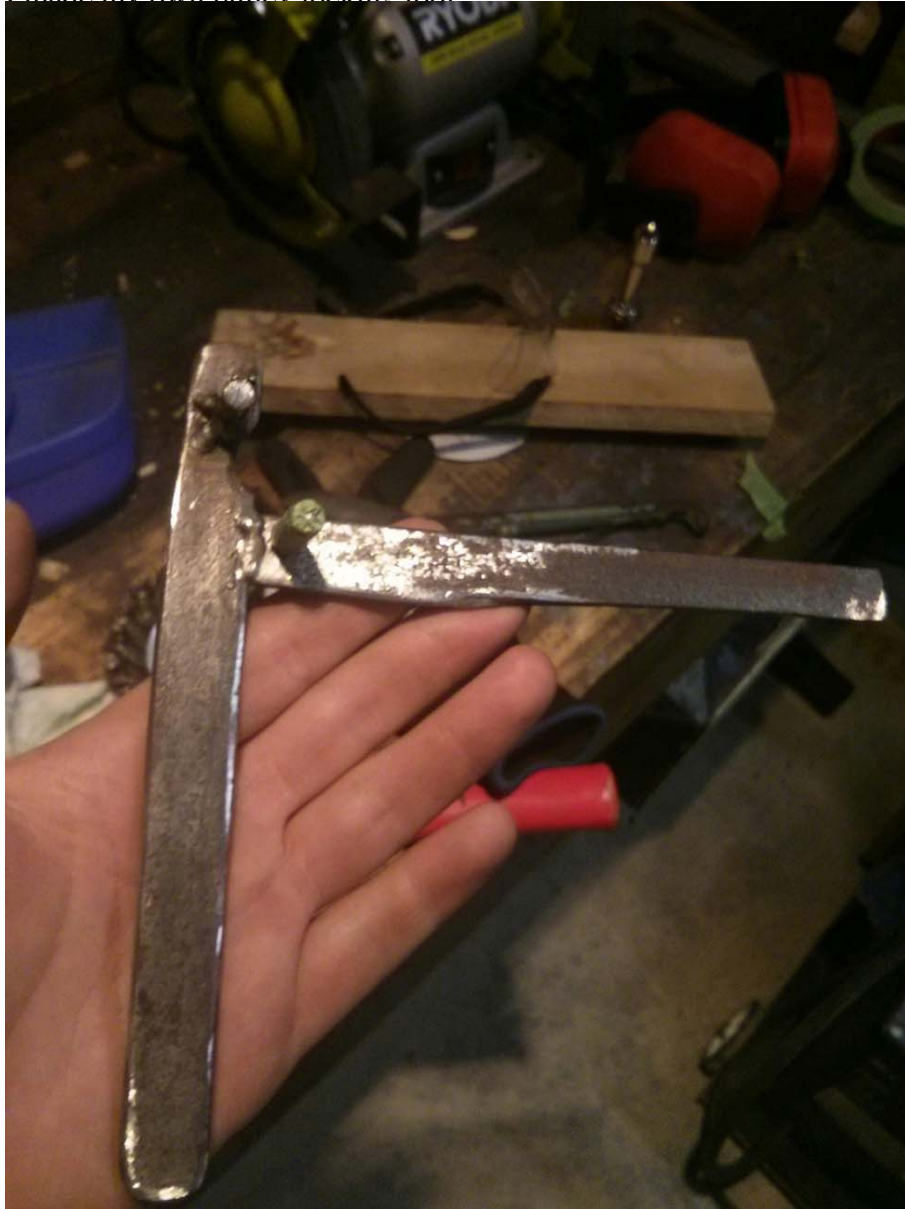
I made my own pulley locking tool:

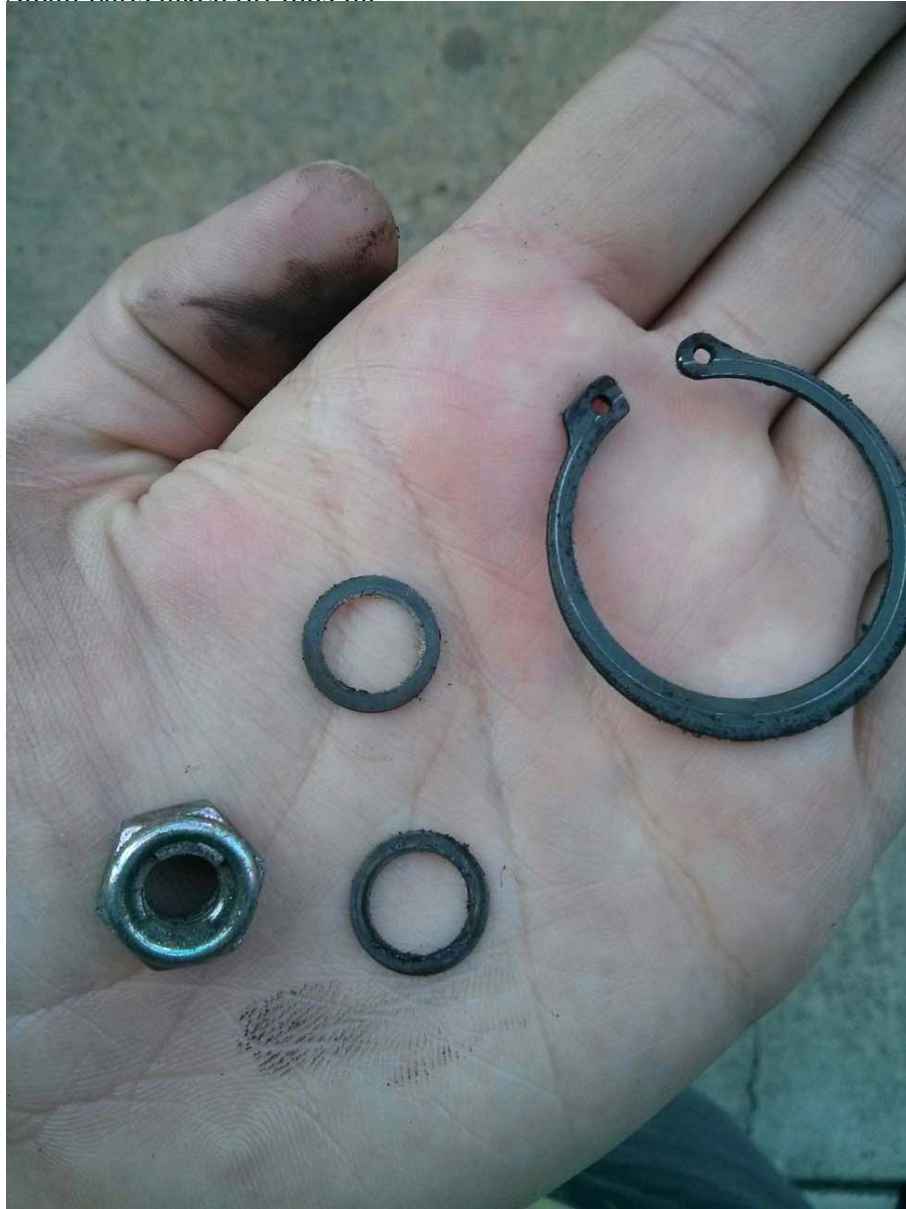
Small parts taken off thus far:
