## DTC 44 V8 PCM

### LEAN EXHAUST INDICATION

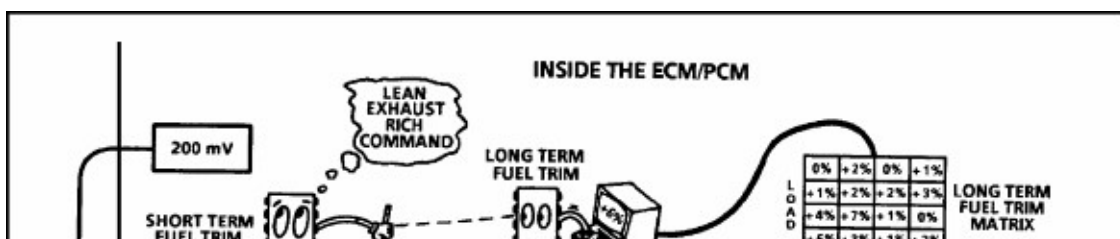
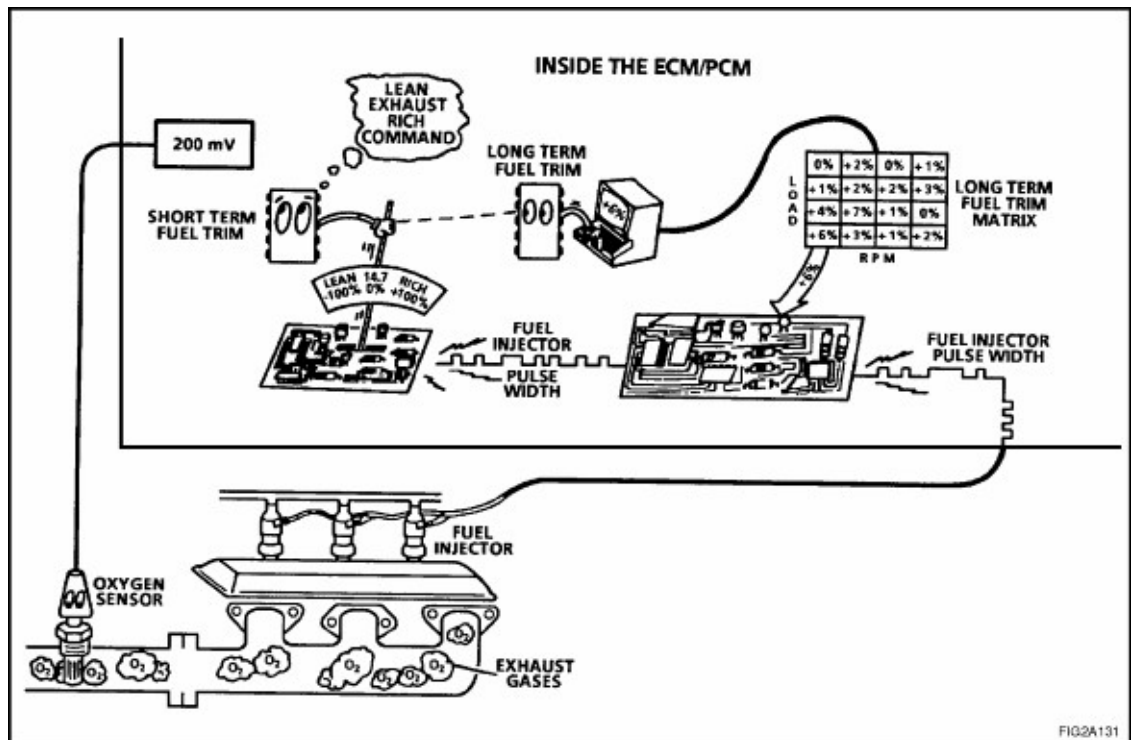
FIG2A131

#### Circuit Description:

The PCM supplies a voltage of about 450 millivolts between terminal "C14" and "C13". The Oxygen (O<sub>2</sub>) sensor varies the voltage within a range of about 1 volt if the exhaust is rich, down through about 100 millivolts, if exhaust is lean.

The sensor is like an open circuit and produces no voltage when it is below about 360 degrees C. An open sensor circuit or cold sensor causes "Open Loop" operation.
